Manhole Inspection Summary

Manhole # S150O1010MH

Insp Date: **6/20/07 10:32 AM**

Location Address: **2605 GREENSPRING AVE**

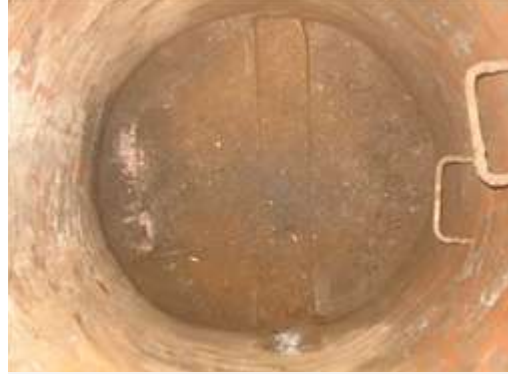
Top View

Corroded steps. Evidence of surcharge - Bench debris. Channel debris.

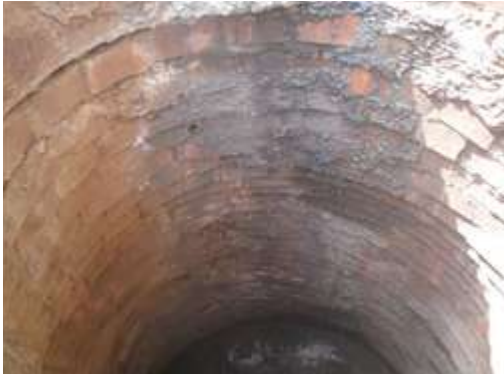
Defect

Frame leaks. Adjustment deterioration and infiltration. Corbel and Barrel infiltration.

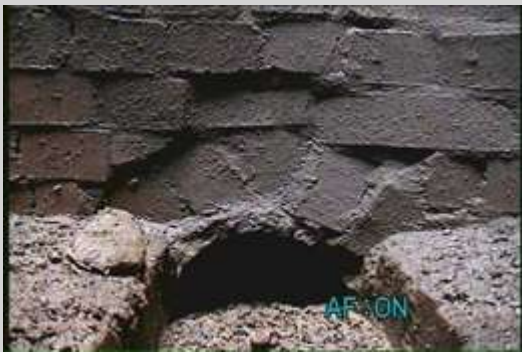
8 in. Circular Gravity Sewer
Pipe Out @ 12 O'Clock

debris in channel

Deposits: ☐ None ☐ Mud ☐ Sludge ☒ **Debris** ☐ Grease

Infiltration: **Evidence** Pipe Seal Cond: **Unknown**
